Tales from the Tank

Analyses of Site Inspections

Maine CDC
Division of Environmental Health

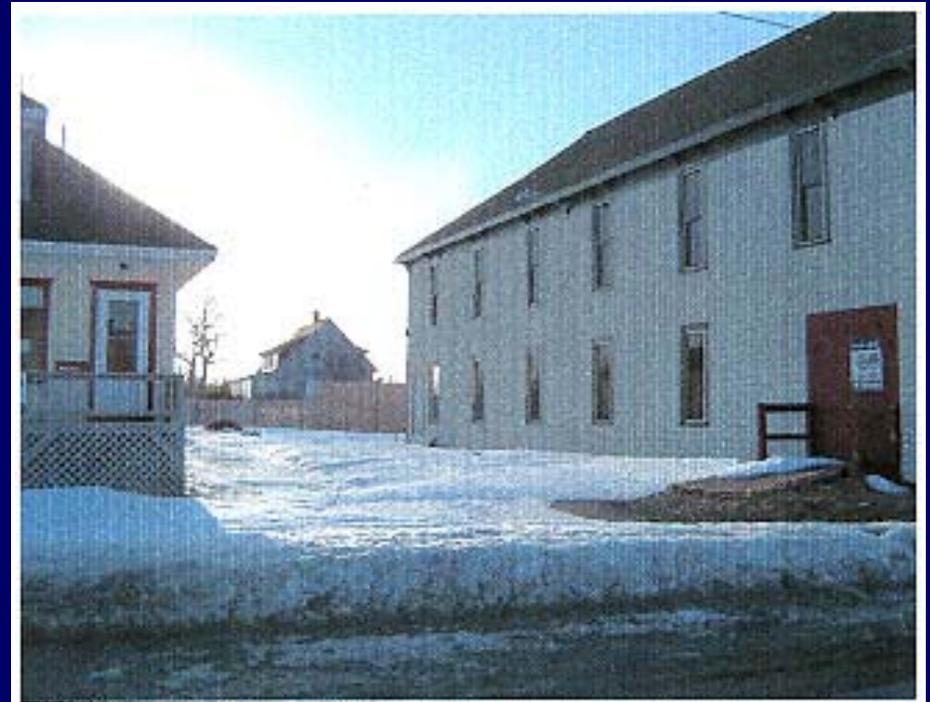
A complaint was received from an abutting property owner that the septic system serving a Grange Hall and a library was illegal because:

- no permit was issued,
- the library was illegally tied into the Grange Hall system, and
- the system was too close to the abutter's property.

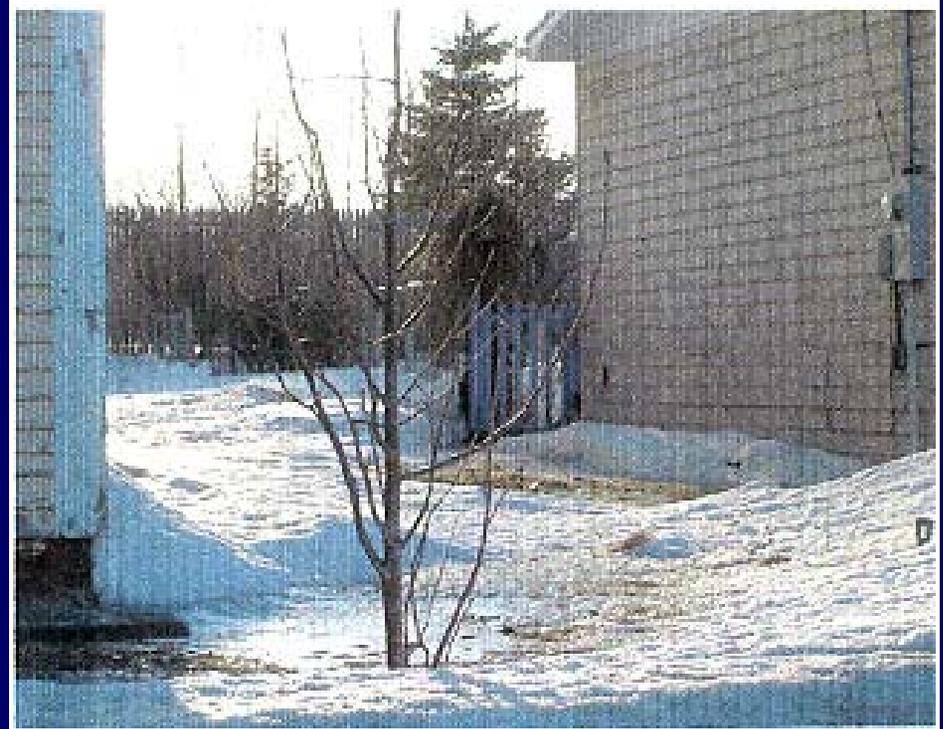
A record search was done and a permitted HHE-200 was not found for either structure.

Portions of the system were excavated and the system was found to be in compliance with today's standards, for the Grange Hall use. The library was hooked into the same septic system.

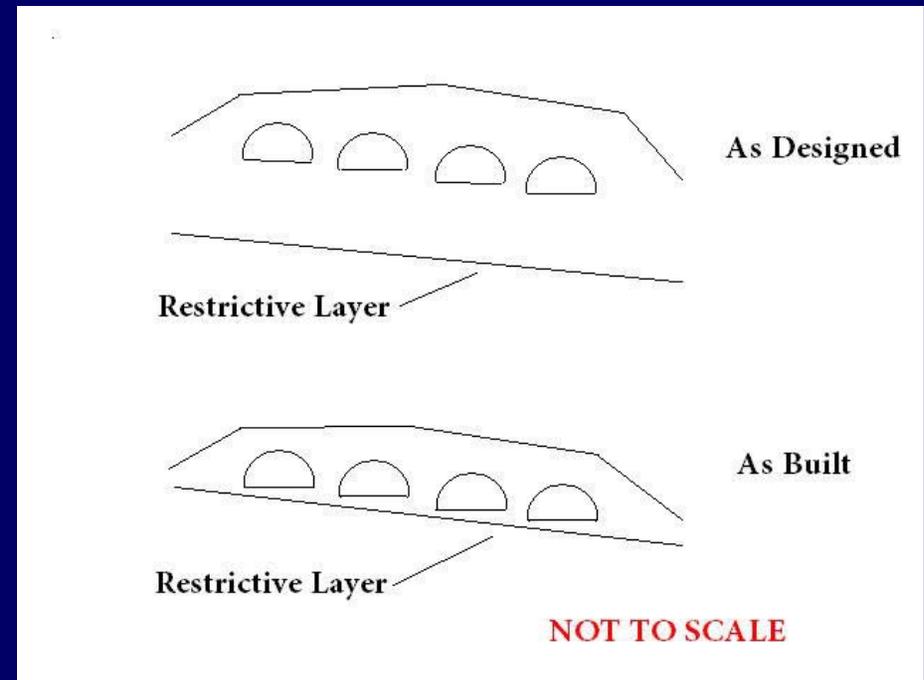
The cross section of the disposal area design (plastic chambers) showed 19 to 22 inches of Rules-compliant backfill material under the chambers.

As built, the soils under the chambers were comprised of an inch or less of gravelly coarse sand over a firm, very fine sandy loam to silt loam.

Soil conditions below the chambers did not allow infiltration. This and insufficient fill led to ponding in the disposal area and a hydraulic break out.

Solids carry over from the tank were observed. The 6 bedroom duplex had one 1500 gallon tank, which led to the carry over.

The malfunctioning disposal area had to be replaced as it was too close to a limiting factor and had been sealed at least in part by solids carry over from the septic tank.

The Division recommended that a new disposal area be designed and installed.

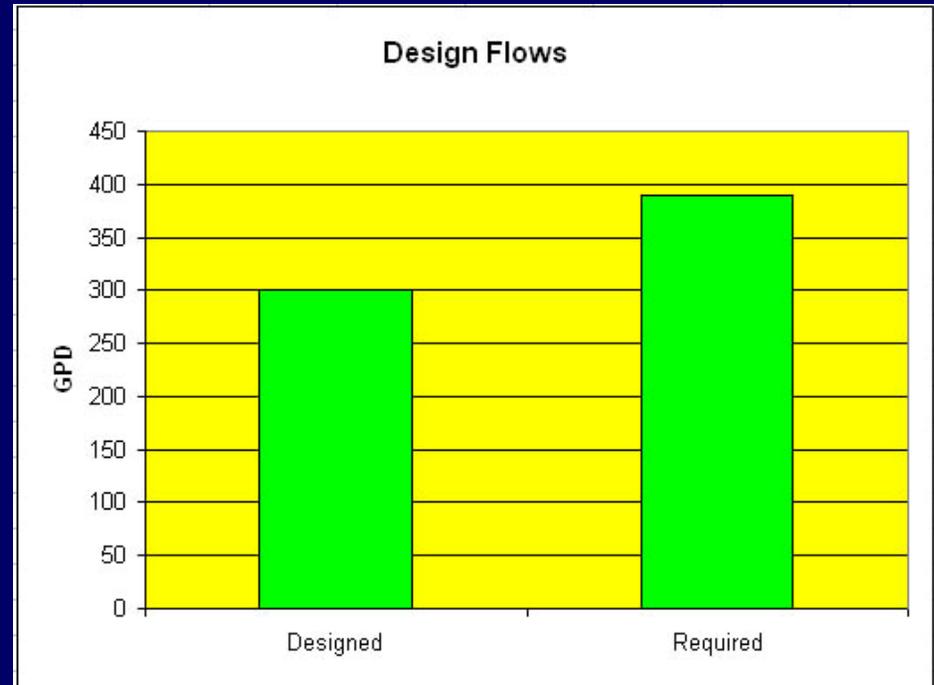
A complaint was received that a system serving a three bedroom residence was malfunctioning after only 1 ½ years of use. The system actually served a three bedroom dwelling with a one bedroom apartment.

The HHE-200 Form for the system had a design flow of 300 gallons per day (gpd) for a two bedroom house and one bedroom apartment, whereas a design flow of 390 gpd was required (270 + 120).

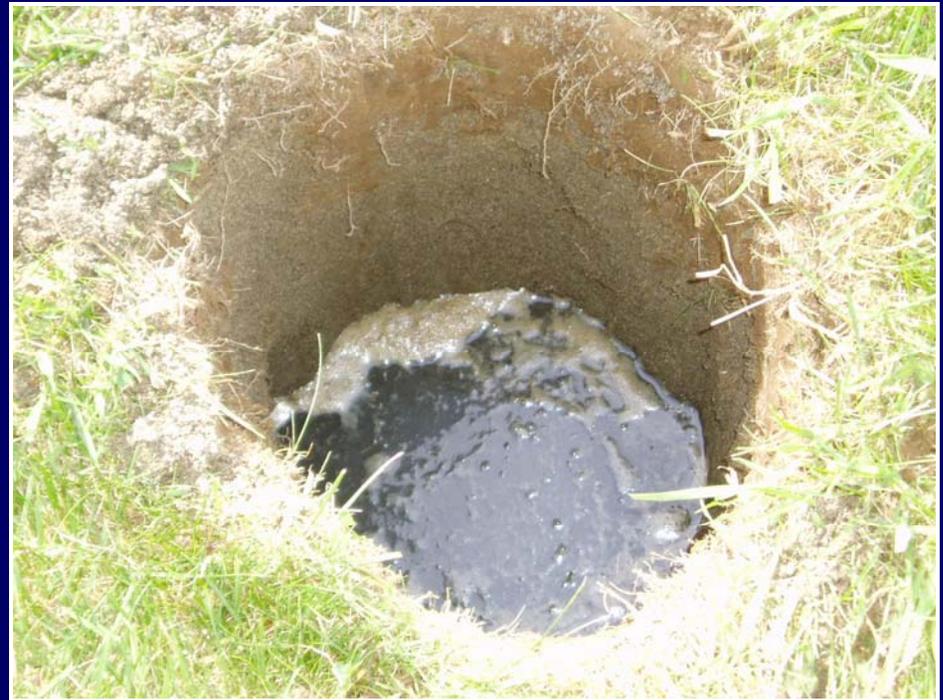
Effluent was found ponded to the top of the stone layer, indicating inability of the bed to drain.

It was determined that the fill material under the chambers did not meet the requirements of the Rules and was the major cause of the malfunction.

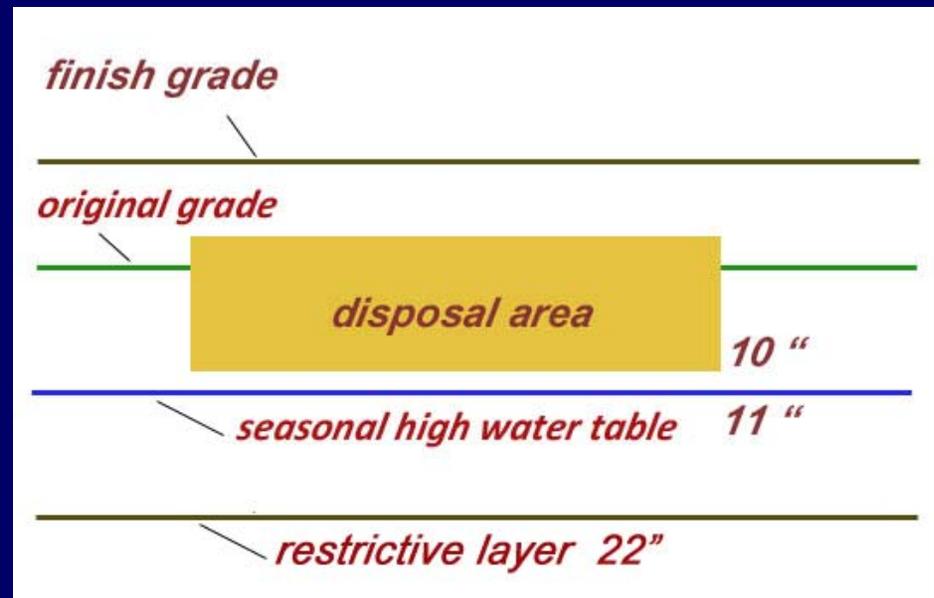
Soils were gravelly sandy loam with a seasonal high water table at 11 inches and free water at 15 inches below grade.

The HHE-200 Form indicated a restrictive layer at 22 inches and made no mention of the seasonal water table.

The design showed a 10 inch cut into native soils, placing the bottom one inch above the seasonal high water table.

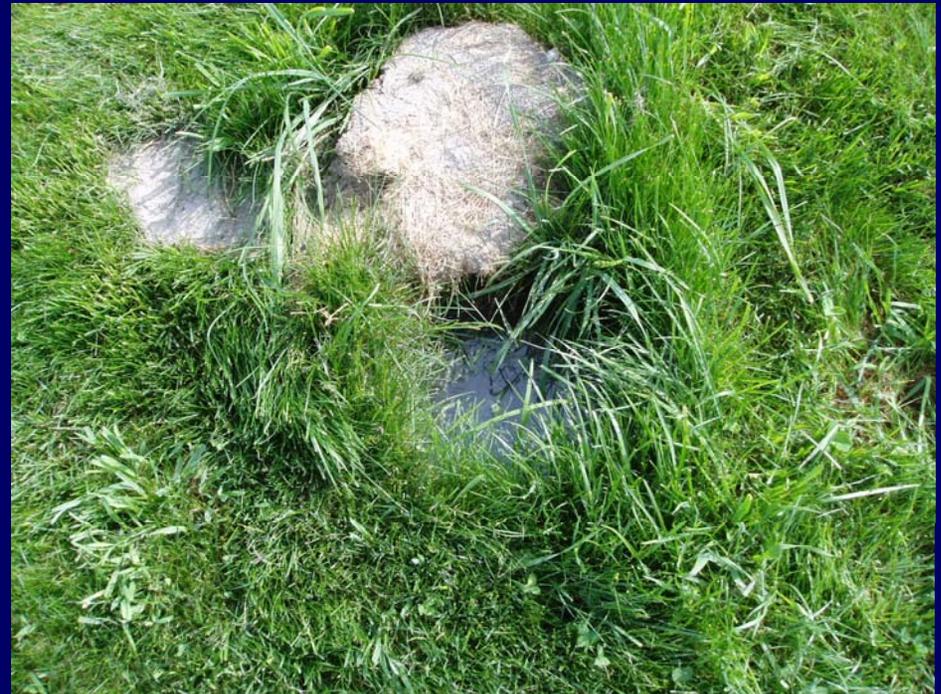
The disposal area failed due to a combination of unsuitable fill material, inadequate separation from the seasonal high groundwater table, and being overused by the owner with respect to its design flow.

The Division advised the owner to install a properly sized new disposal area at the proper elevation from the seasonal high water table.

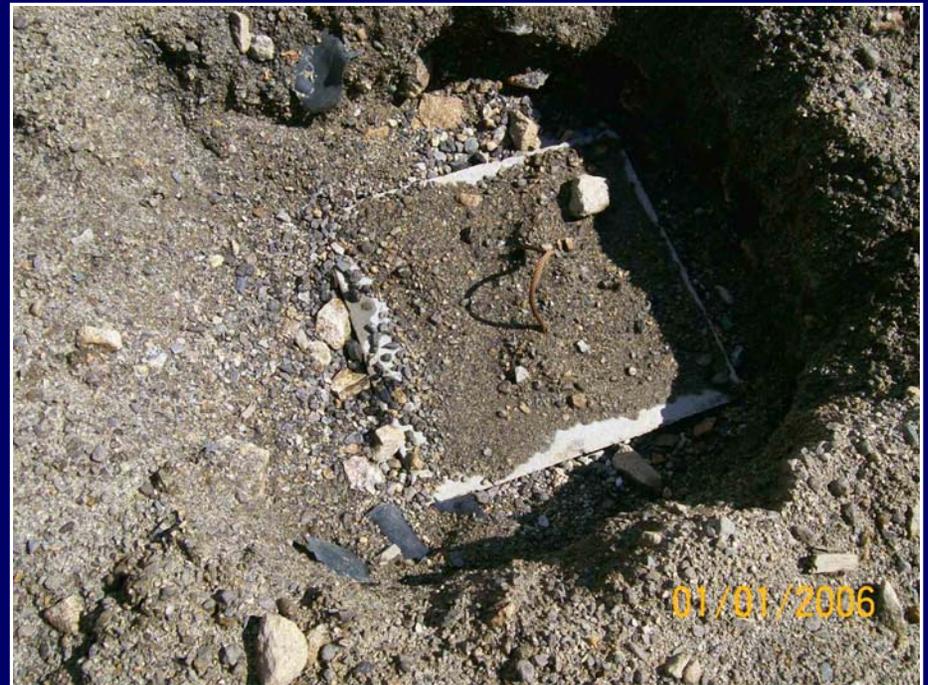
An ATU was installed in the system without its remote monitoring system. Thus the ATU operated below specs with solids carry-over without anyone knowing.

There was no sign of hydraulic malfunction during the inspection. However, effluent could be seen sputtering around the seam of the distribution box lid.

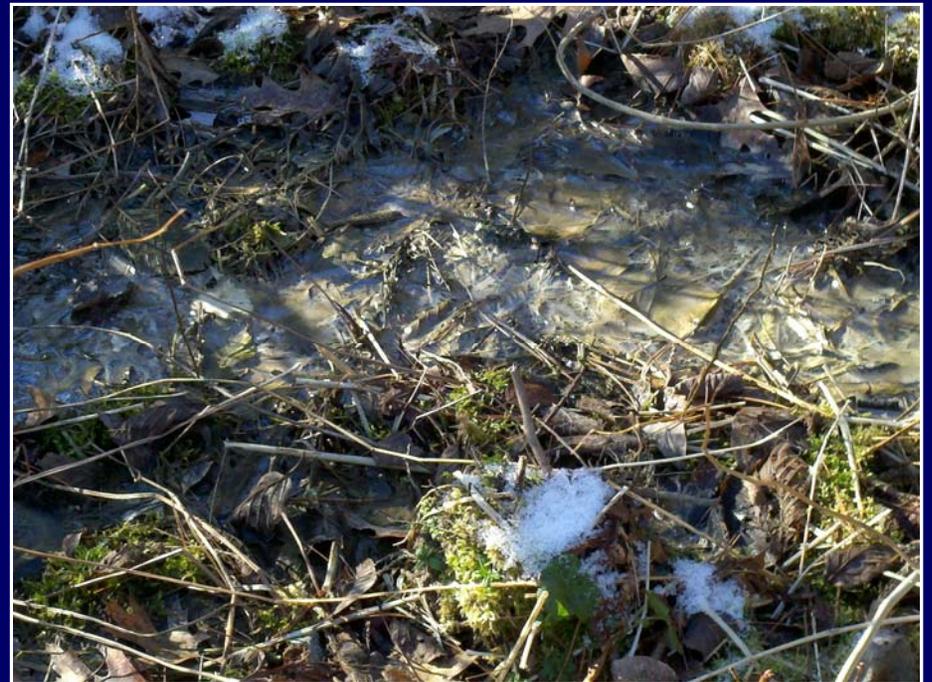
In December, the LPI discovered a hydraulic malfunction (breakout) at the original disposal area. The LPI contacted the Division immediately with photos.

On the basis of the malfunction, the Division rescinded approval for use of the original disposal area and restricted use of the new disposal area to 2,000 gpd.

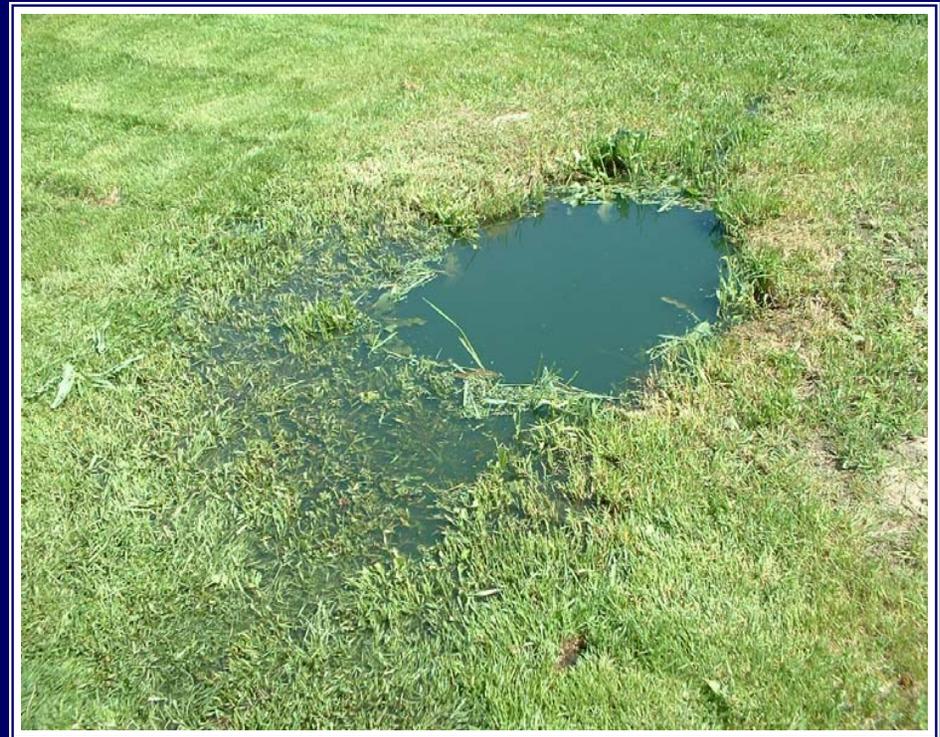
An LPI found that a commercial laundry's system was malfunctioning, clearly evidenced by effluent flowing on the ground surface.

The laundry operator had begun accepting laundry from several nearby summer camps. The increased use of the system strained it to the point of hydraulic malfunction.

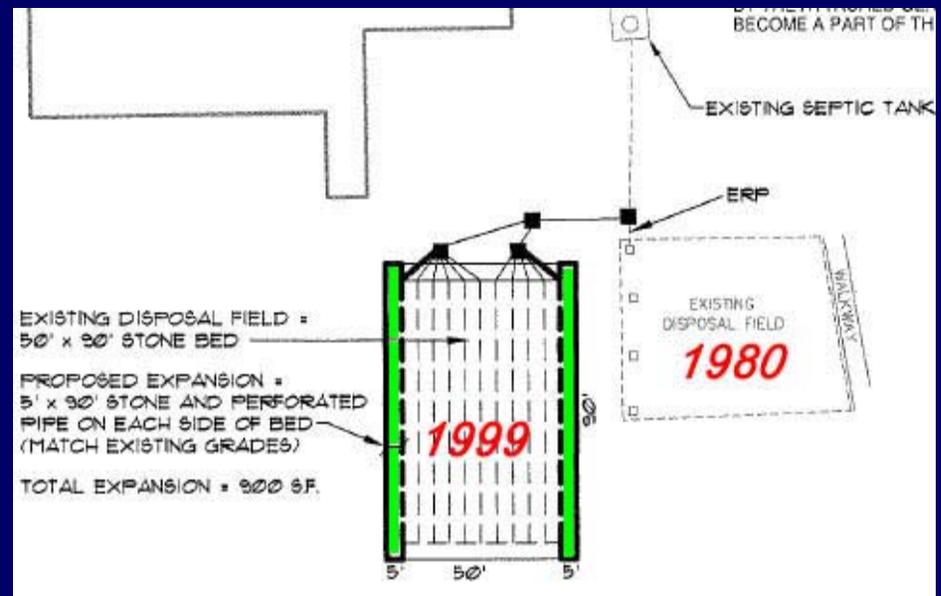
The original system included two disposal areas known as the 1980 bed and the 1999 bed. It was the 1980 bed which had malfunctioned.

The owner's engineer proposed to the LPI adding stone trenches abutting the 1999 disposal area as a stop gap solution. At that time the LPI asked the Division to review and comment on the proposal.

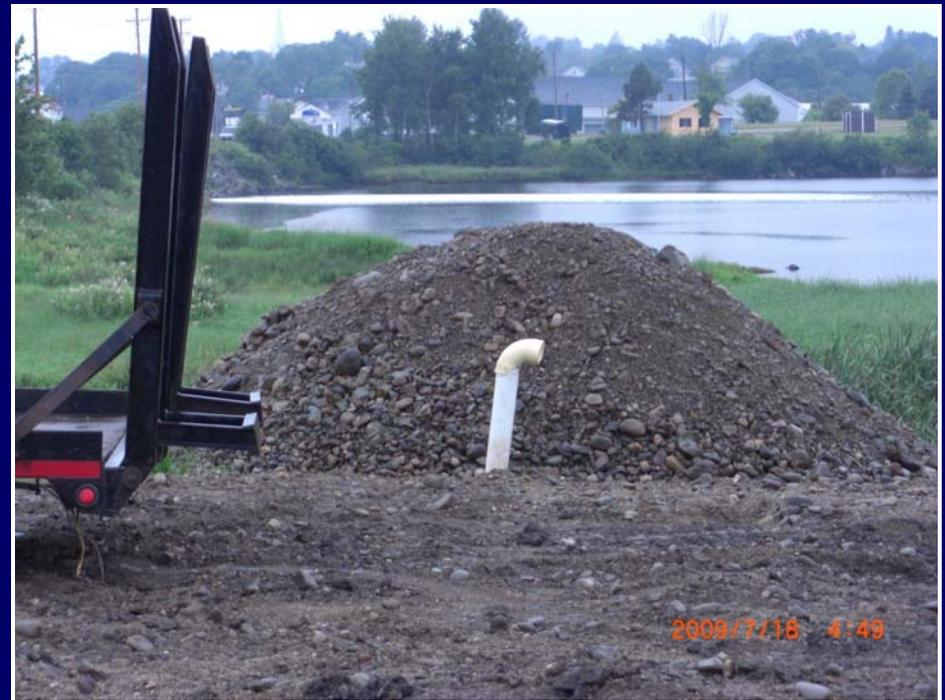
DEH staff inspected the site along with interested parties. The system was malfunctioning, as effluent was observed exiting a vent pipe.

The owner's SE found that the grease trap had been piped incorrectly allowing grease to enter the pump station and then directly into the disposal field.

The system stopped malfunctioning after the grease trap was cleaned and re-piped, and the tank was pumped.

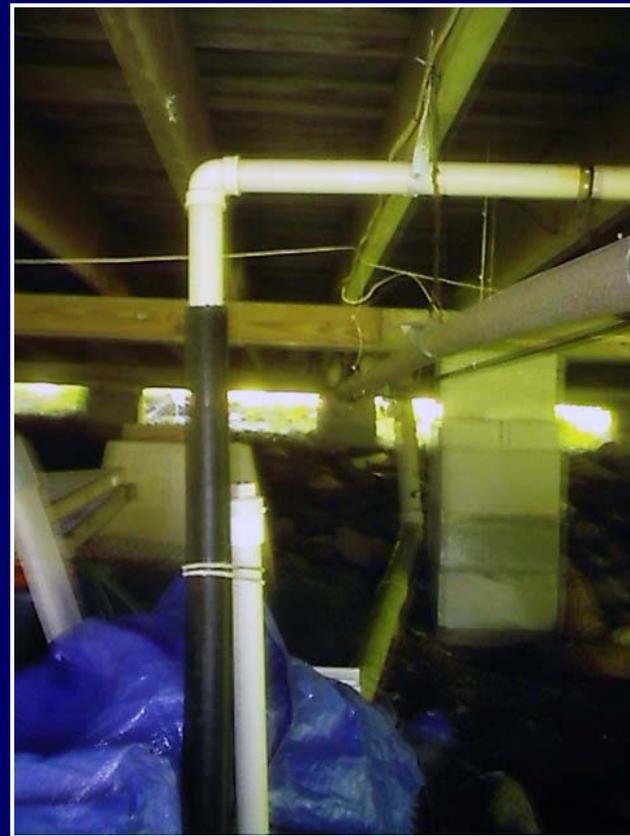
Staff discovered that the drain line from the laundry room and kitchen sink had been cut, and the stub to the building drain had been capped. The greywater drain was connected to a black polyethylene pipe.

This polyethylene pipe extended to a hole in the ground covered by two rocks and a piece of pressure treated wood, comprising an illegal, nonconforming greywater disposal pit.

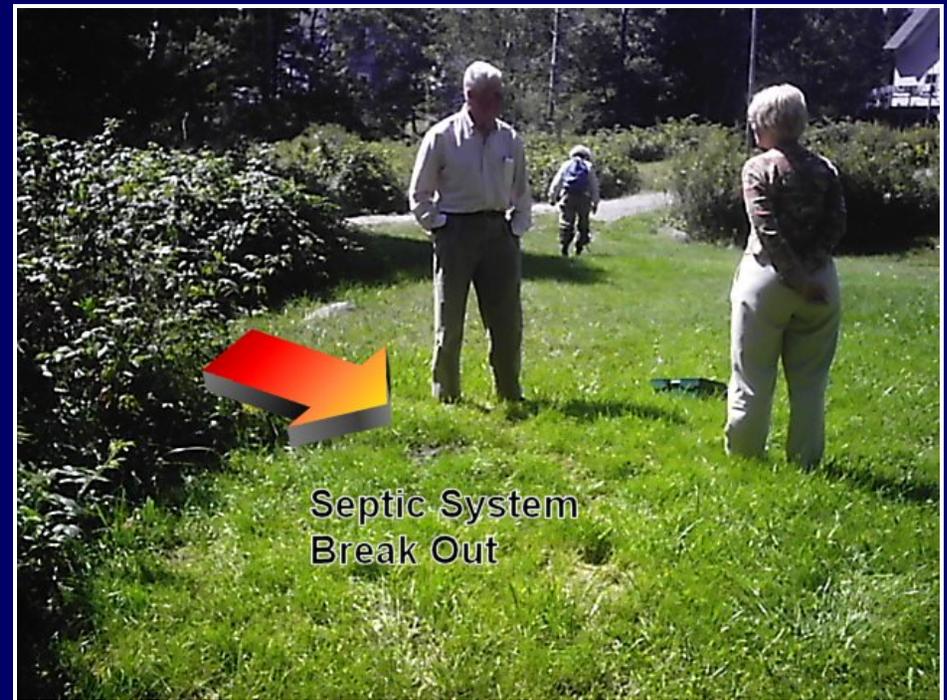
There also was evidence of an ongoing malfunction of the main disposal area, evident by a black, very wet area adjacent to an area overgrown with brush.

The coloration suggested this was a chronic condition. The outbreak was set back +/- 200 feet from the normal high water mark of the cove and +/- 127 feet down slope from the property's well.
