Tales from the Tank

Analyses of Site Inspections

Maine CDC
Division of Environmental Health

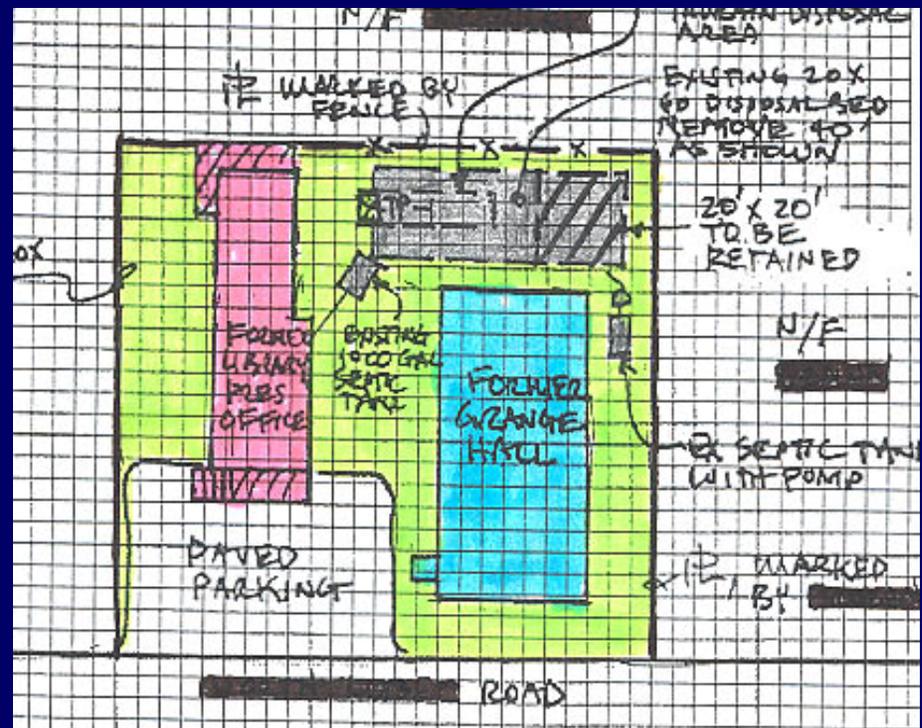
The original system was illegal because it was installed without a design or a permit.

The original system fortunately met the requirements for the Grange Hall.

A larger system was needed to accommodate both structures, and one was designed.

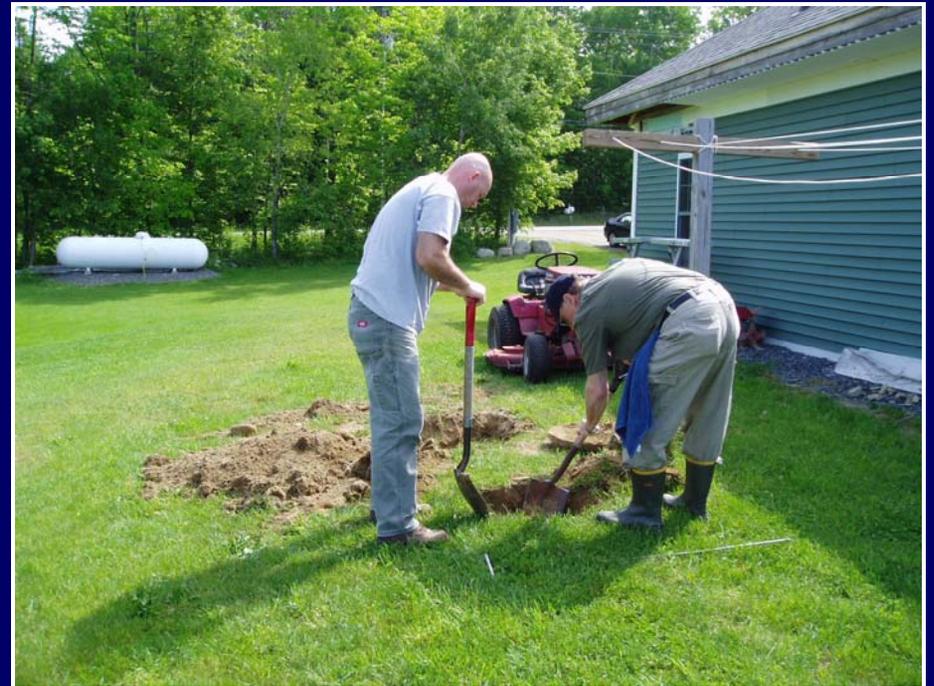
Division staff performed a site inspection accompanied by the LPI, the SE, and the owner.

Three test pits were dug by hand, one on top of the system, one on the side of the system and one about 10 feet off the southeast corner of the system.

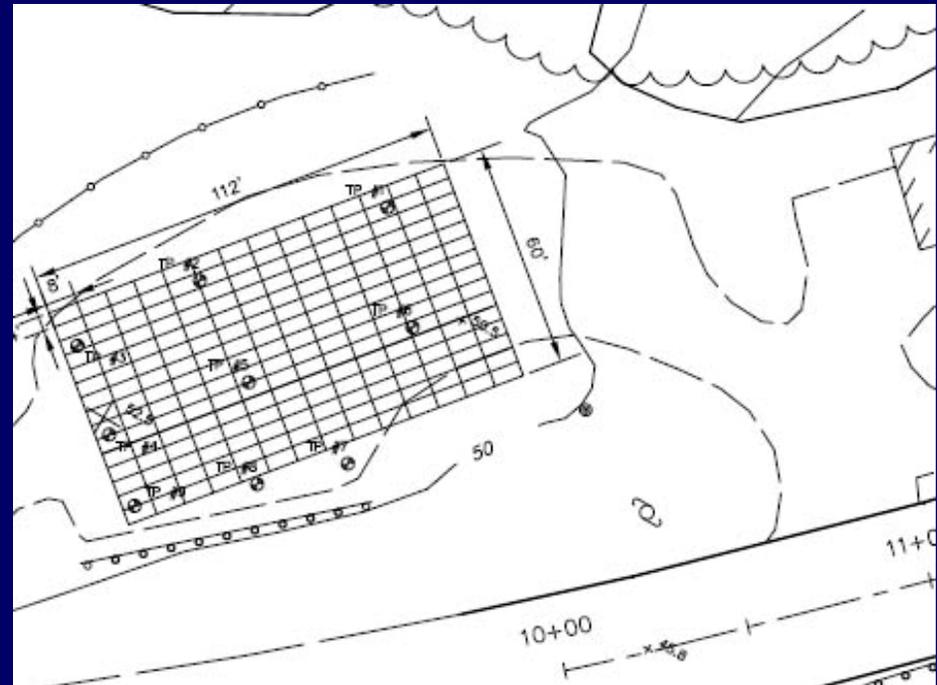
The Division received several e-mails in one day last August, alleging that an engineered system serving a restaurant had malfunctioned.

Division staff from SWU and HIP performed a same-day site inspection in response to the complaints, due to the potential for an imminent public health hazard.

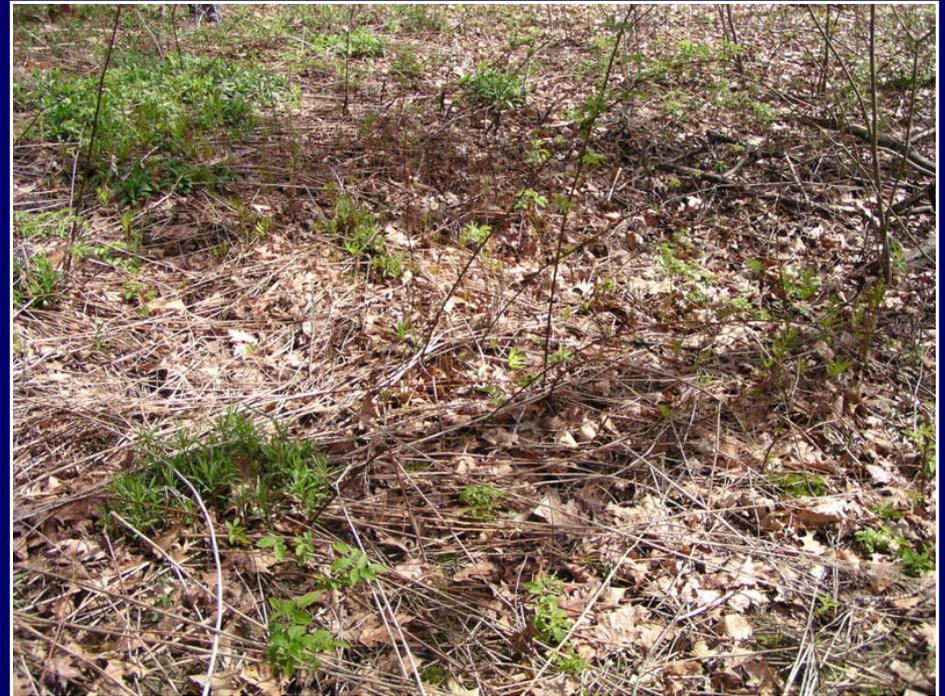
The design engineer proposed to divert 100% of the flow to the original disposal area for an indefinite period. This was to allow the new disposal area a chance to rejuvenate itself and accommodate metabolizing the solids in the disposal area.

The Division approved this proposal for a period not to exceed 30 days, at which time an assessment of the situation would be made.

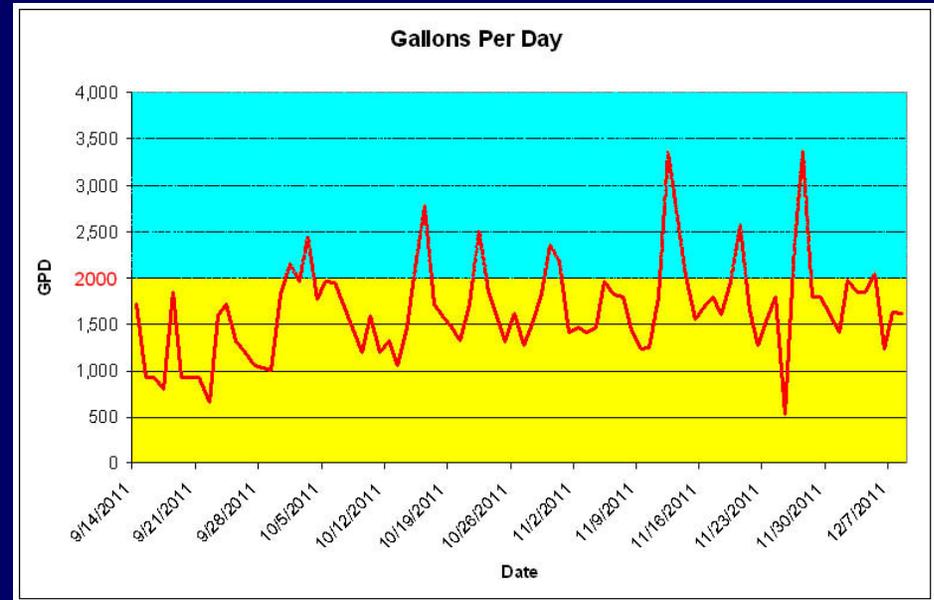
Effluent was diverted to the original disposal area intermittently over the next few months, typically during weekends when the restaurant was generating peak flows. This was contrary to the approved proposal.

According to the weekly reports which the design engineer had been submitting, the restaurant had generated more than 2,000 gallons per day on several of these weekends.

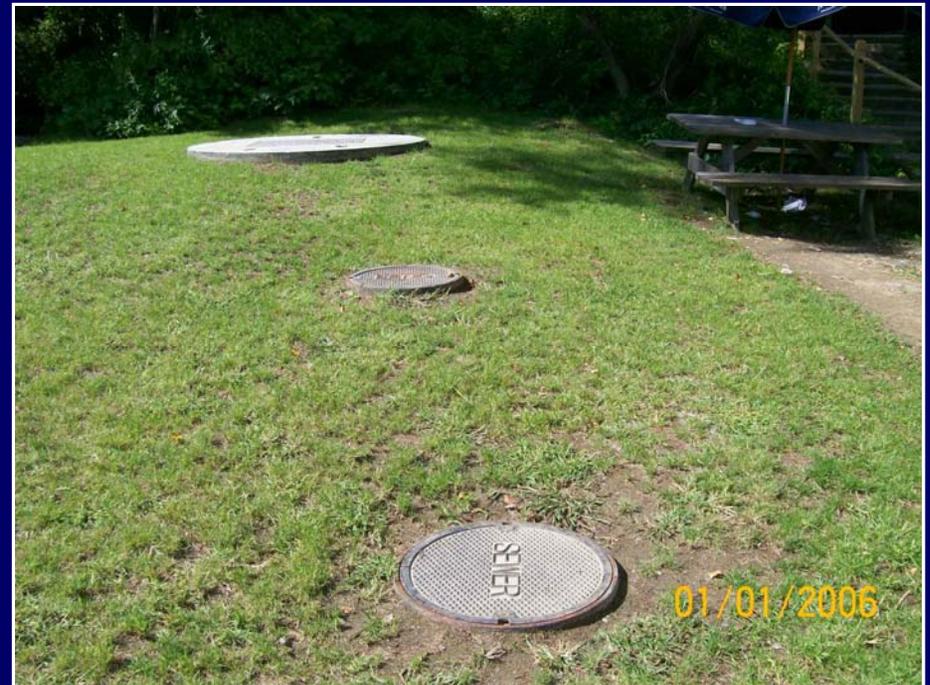
Weekly reports filed since the malfunction of the original disposal area show that the system use has not exceeded 2,000 gpd. In several instances this required pumping out the system before a peak flow was expected.

If this system fails, it will need to be replaced. Given space limitations it would likely be *in situ*.

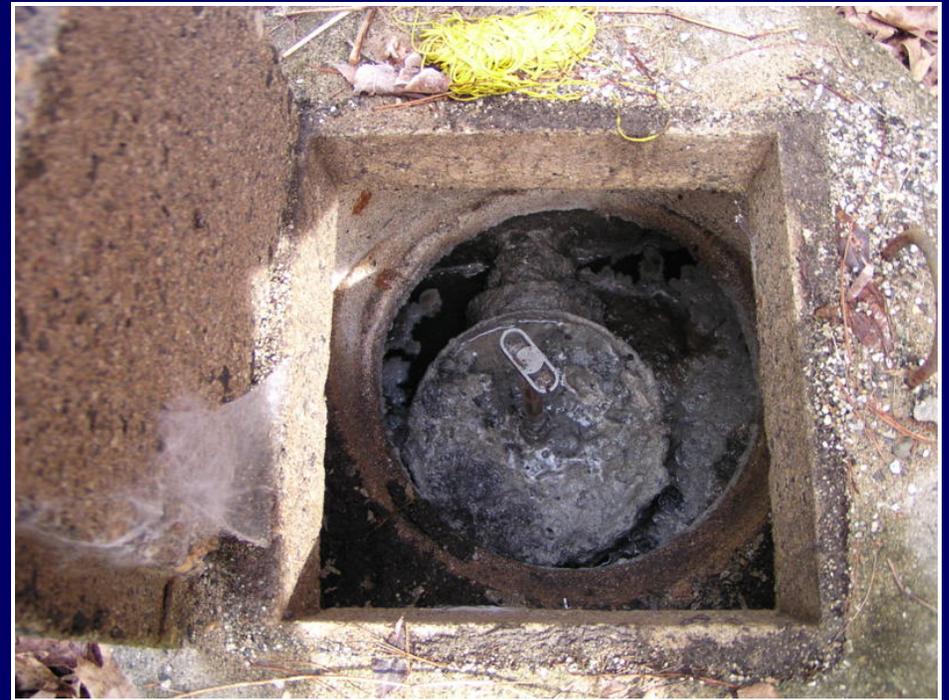
The system faced two major obstacles to proper functioning:

- (1) improper installation of the ATU with resulting solids carry over and
- (2) chronic and extensive over use of the system by the owner.

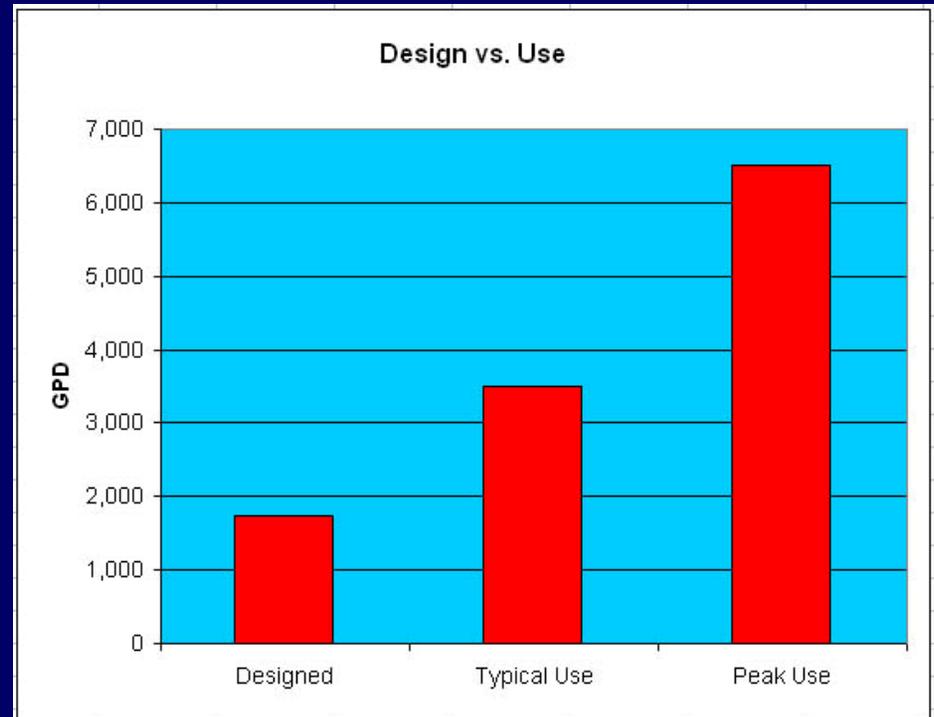
An LPI found that a commercial laundry's system was malfunctioning, clearly evidenced by effluent flowing on the ground surface.

Typical use by the owner of the laundry was 3,500 gpd, slightly more than 200% of the design flow.

Peak use for the summer months was 6,500 gpd, or 375% of the design flow.

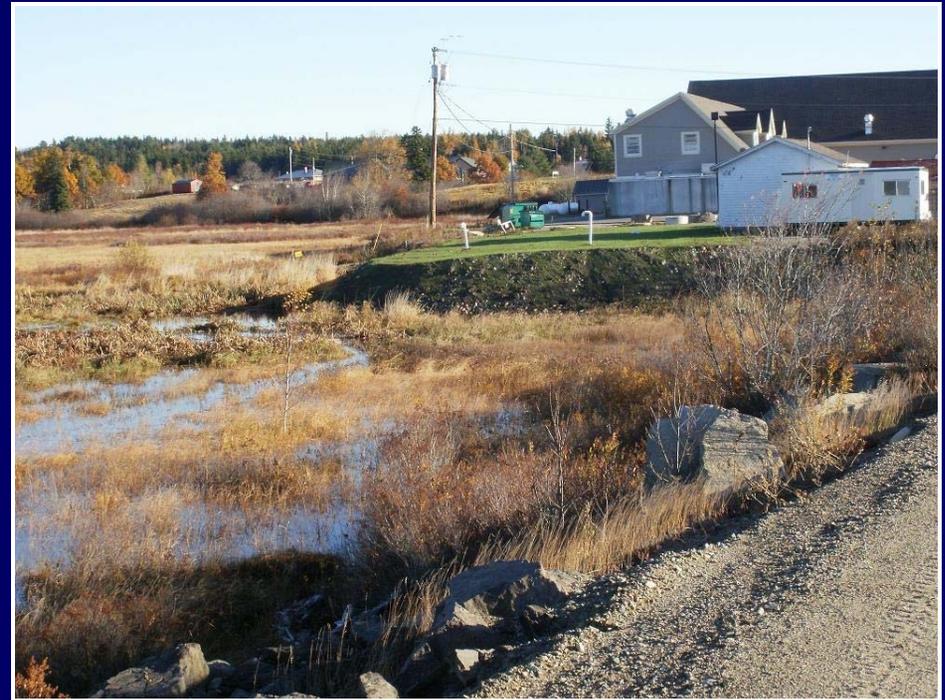
USEPA forwarded a complaint to MDEP, who forwarded it to DEH. The complainant alleged that a septic system serving a multiple use commercial property was malfunctioning and discharging to a regulated wetland.

The property was comprised of a doughnut shop, a sandwich shop, a limited menu eating place, and 2 residential apartments in a relatively recently replaced structure.

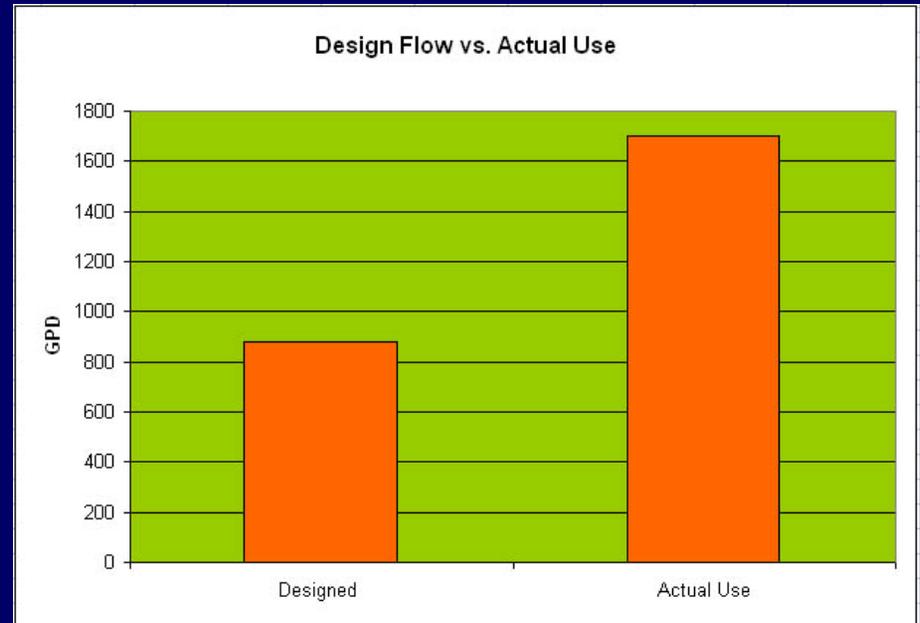
The system that served the prior building malfunctioned in 2005 and was replaced with the subject system, designed for 880 gpd for a doughnut shop with 15 seats, 10 office workers and takeout sandwich shop.

The owner stated that the water meter indicted water usage at about 1700 gallons per day.

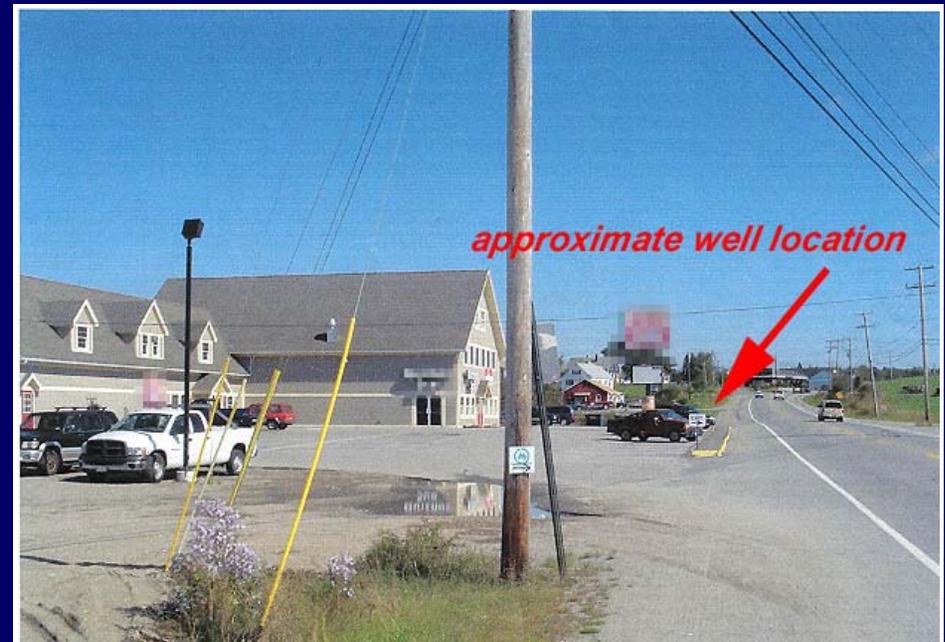
The well for the facility is located in the northeast parking lot as shown on the SE's design, less than 300 feet from the proposed system.

The SE suggested relocating the backwash from the water purification system to its own disposal system to reduce the flow to the disposal system. This would have required a DEP license.

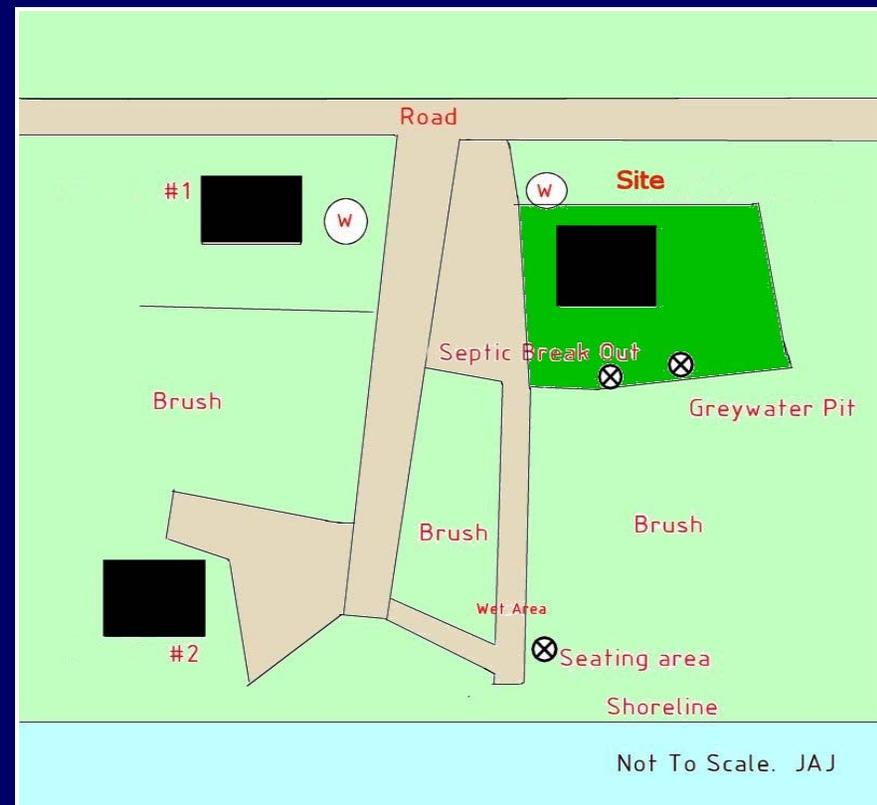
A site inspection was performed at the subject property on August 27, 2009. Present were staff from the Department of Marine Resources and the Division of Environmental Health, Subsurface Wastewater Program, two abutters, the Local Plumbing Inspector, the Town's Emergency Management Director, and the First Selectman.

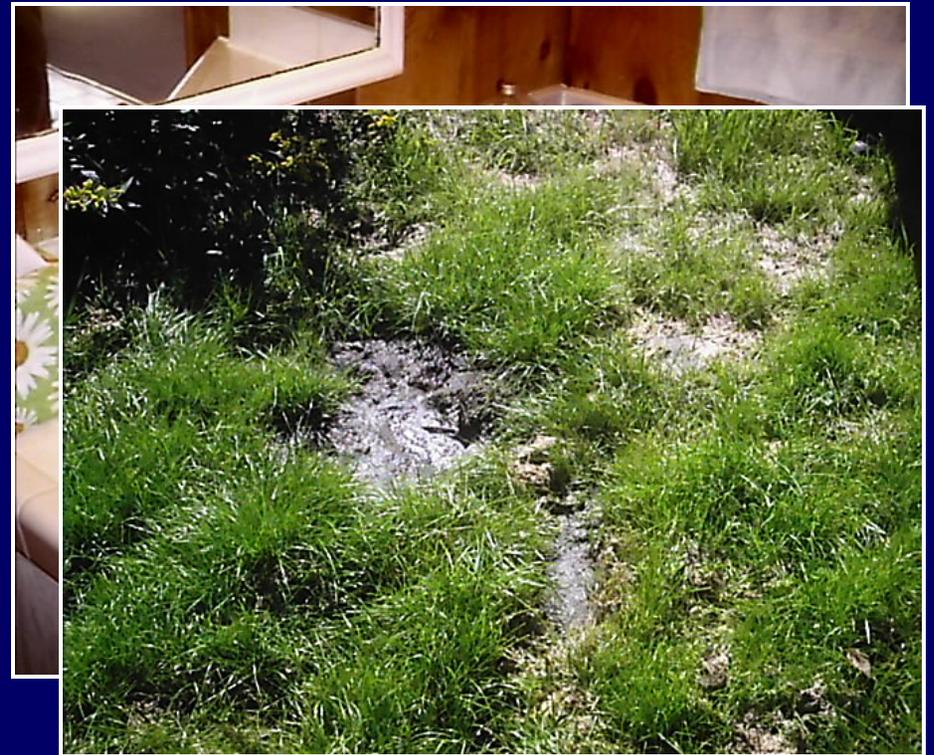
Water samples from the dwelling were delivered to the DHHS Health and Environmental Testing Laboratory. DMR staff sampled the effluent and sent it to the CDC in Atlanta.

The water was positive for E. coli and the effluent was positive for Hepatitis A.
